CAFO FACILITY INSPECTION REPORT

<u>8335286001A</u> WDID NUMBER	<u>Pete Vanderham</u> OWNER NAME	<u>Pete Vanderham Dairy</u> FACILITY NAME
<u>CAG018001</u> NPDES NUMBER	<u>Ex. 6 Personal Privacy (PP)</u> OWNER ADDRESS FACILITY ADDRESS	
<u>R8-2007-0001</u> RWQCB ORDER NO.	<u>Mira Loma, CA 91752</u> OWNER CITY AND STATE	<u>Mira Loma, CA 91752</u> FACILITY CITY AND STATE
<u>03/07/2013</u> SCHEDULED INSPECTION DATE	<u>Pete Vanderham</u> OWNER CONTACT	<u>Pete Vanderham</u> FACILITY CONTACT
<u>03/07/2013</u> ACTUAL INSPECTION DATE	<u>Ex. 6 Personal Privacy (PP)</u> OWNER PHONE NO. FACILITY PHONE NO.	
<u>Unknown</u> RECEIVING WATER	<u>Ex. 6 Personal Privacy (PP)</u> FACILITY LATITUDE	<u>Ex. 6 Personal Privacy (PP)</u> FACILITY LONGITUDE

REPORT PREPARED BY: Jared Richardson (PG Environmental, LLC) ON 03/29/2013

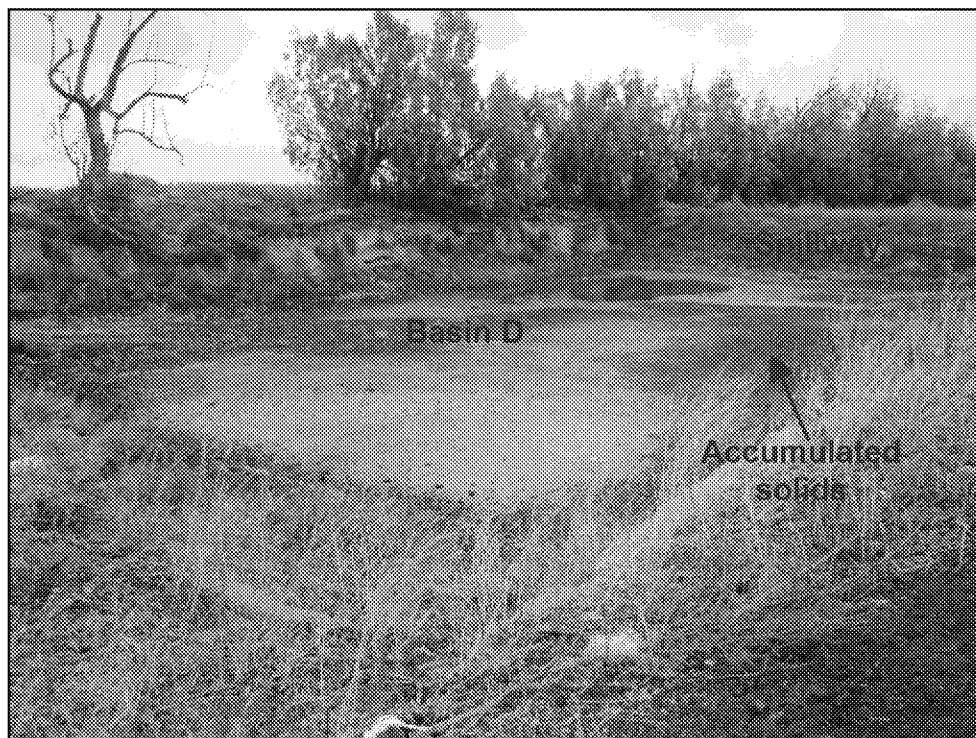
1. Depth markers were not installed in basins A, B, and C, located in the northern portion of the Facility, or in basin D located in the southeastern portion of the Facility, as required by Permit Attachment B - Monitoring and Reporting Program, Section I.B.1 (refer to Photos 4, 6, 9, 10, and 12). This is a recurring issue identified in a previous inspection conducted on December 9, 2011.

1. The inspector observed, during the inspection, that depth markers had not been not installed in basins A, B, and C located in the northern portion of the Facility, and in basin D located in the southeastern portion of the Facility as required by the Permit (refer to Photos 4, 6, 9, 10, and 12). Permit Attachment B - Monitoring and Reporting Program, Section I.B.1 states that "a marker shall be placed within each pond or impoundment to indicate the

4. The inspector observed, during the inspection, accumulated solids in basins A, B and C in the northern portion of the Facility, and in basin D in the southeast portion of the Facility (refer to Photos 4, 7, 11, and 12). Mr. Vanderham stated that the containment structures at the Facility are typically cleaned every summer, and were last cleaned in the summer of 2012. It should be noted that basins B, C, and D did not contain depth markers; therefore, the inspector was unable to determine the depth of accumulated manure solids in the ponds (refer to Photo 4). Section 1.5.4 - 'Operation and Maintenance Plan' of the approved EWMP states "prior to the wet cycle (beginning Oct. 15), accumulated solids and manure shall be removed from the holding ponds to reestablish the design capacity." As a result, the overall capacity of the basins at the Facility may be diminished. Provision VII.C.3.a of the Permit states that "the discharger shall design, construct, and maintain containment structures to retain all wastewater within the facility, including all process wastewater and all precipitation on, and drainage through, manured areas resulting from rainfall up to and including a 25-year, 24-hour rainfall event." The Discharger must design and maintain all containment structures per the approved EWMP as required by Provision VII.C.3.a of the Permit. This is a recurring issue identified in a previous inspection conducted on December 9, 2011.

Photograph 4. View facing southeast of basin D. Note the basin did not contain a depth marker. Also note accumulated solids were observed in the basin. A concrete spillway was located in the southwest corner of the basin.

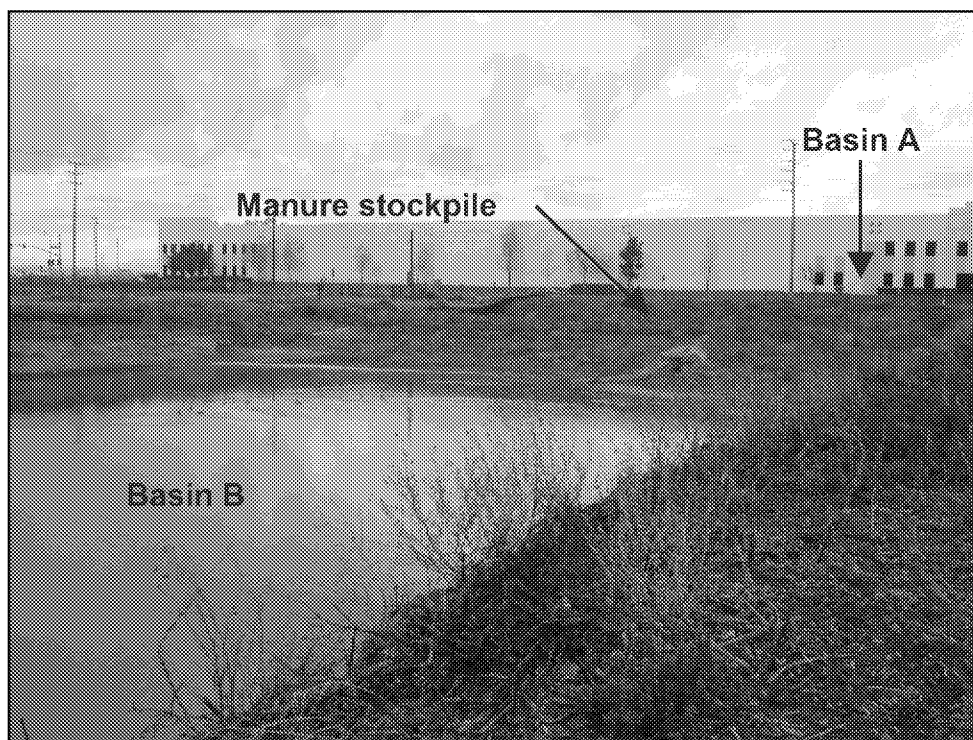
6. The inspector observed, during the inspection, that pond solids/manure had been stockpiled on the existing berms on the western side of basin C, the northern side of basin B, and the southwestern side of basin A (refer to Photos 6 through 9, 11, and 13). Provision VII.C.5.c of the Permit states "no containment structures shall be constructed of manure, and manure shall not be used to improve or raise existing containment structures." Mr Vanderham informed the inspector that the basins were last cleaned in the summer of 2012.

Photograph 6. View facing north of basin B. Note the basin did not contain a depth marker. Also note a manure stockpile was located on the north side of the basin's berm, immediately south of basin A.

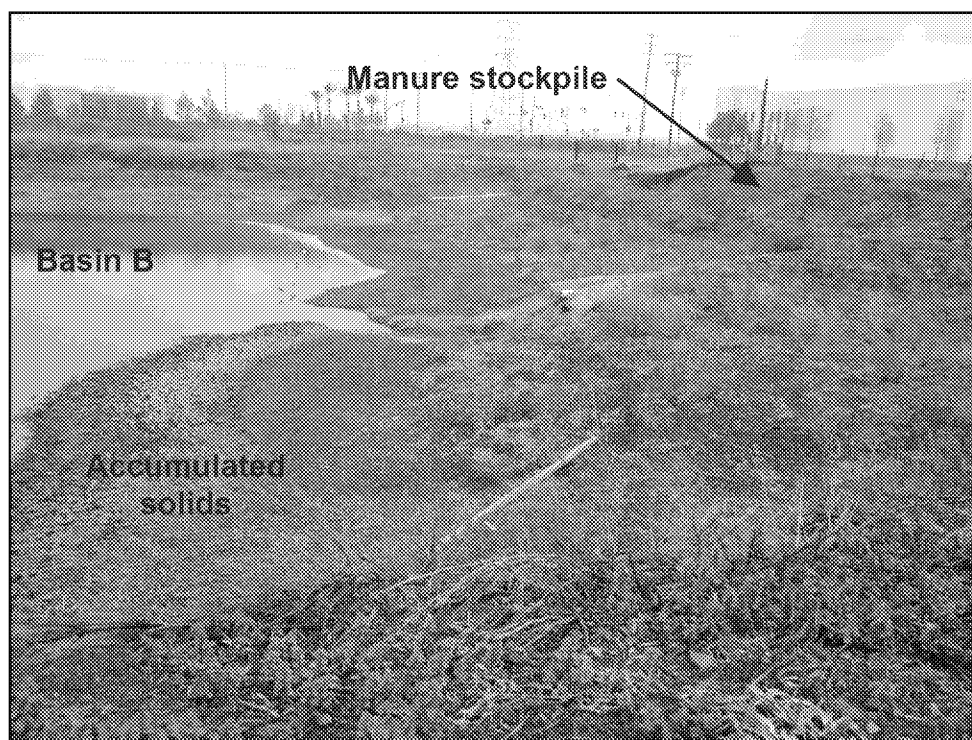
Photograph 7. View facing northwest of basin B, shown in Photograph 6. Note a manure stockpile was located on the north side of the basin's berm, immediately south of basin A. Note accumulated solids was observed in basin B.

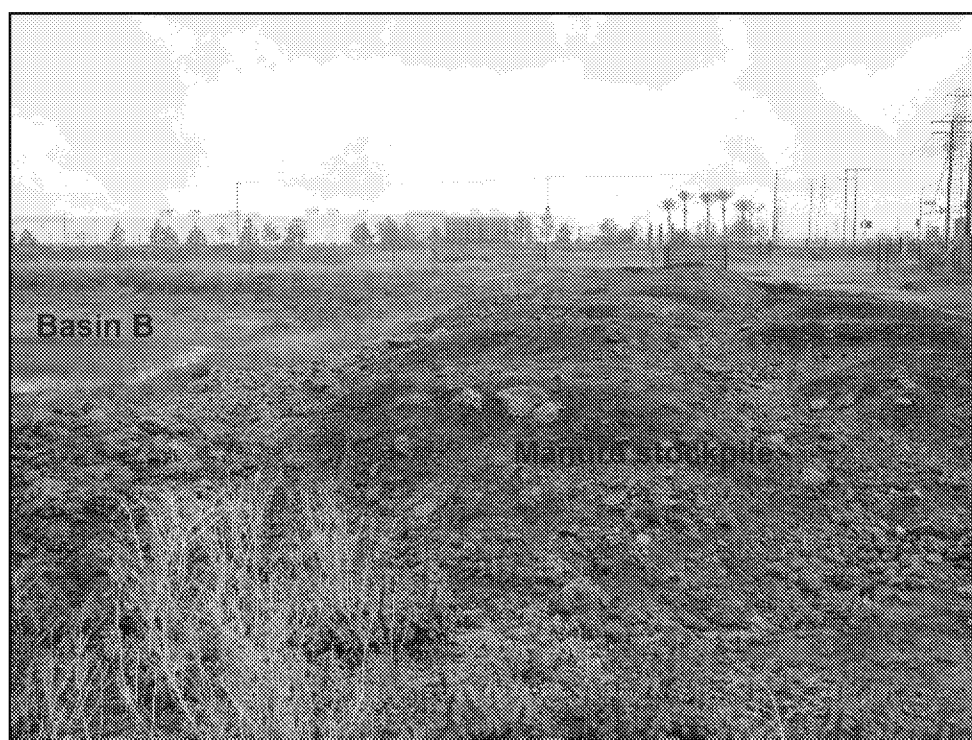
Photograph 8. Close-up view facing west of the manure stockpile located on the north side of basin B berm, shown in Photograph 6 and 7.

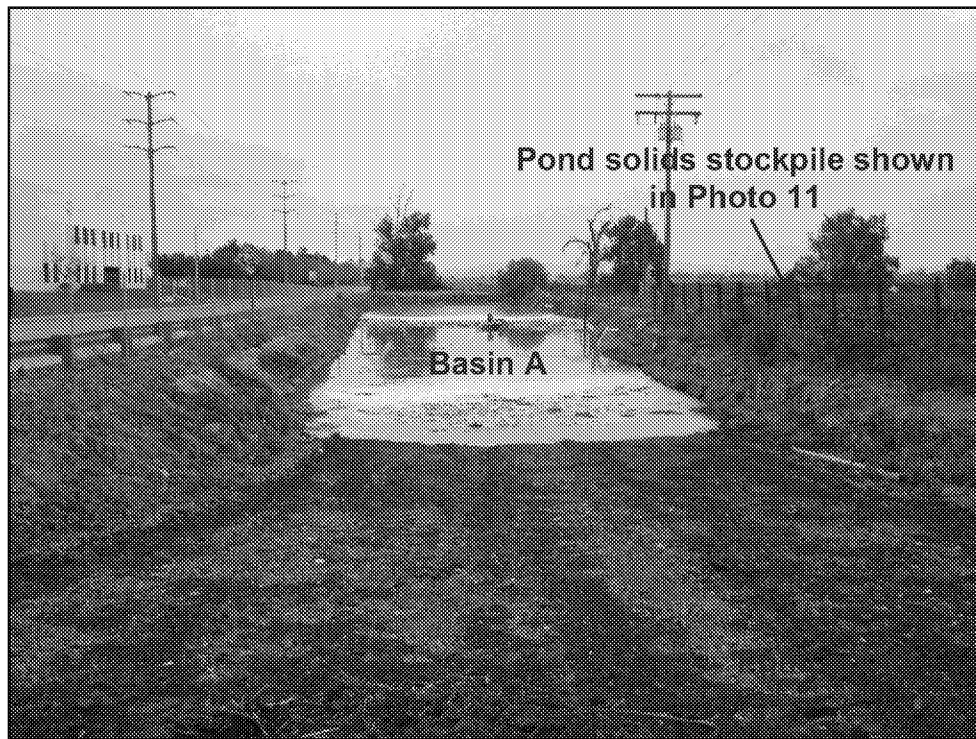
Photograph 9. View facing east of basin A. Note the basin did not contain a depth marker. Also note a manure stockpile and/or removed pond solids was located immediately south of the basin.

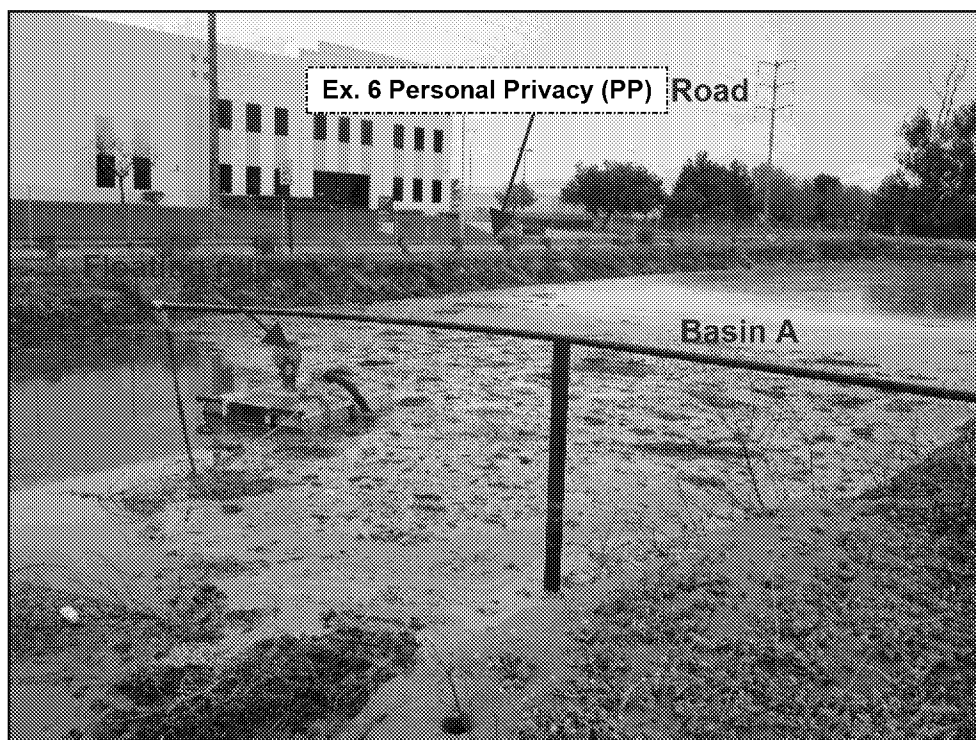
Photograph 10. View facing northeast of basin A, shown in Photograph 9. Note the basin did not contain a depth marker.

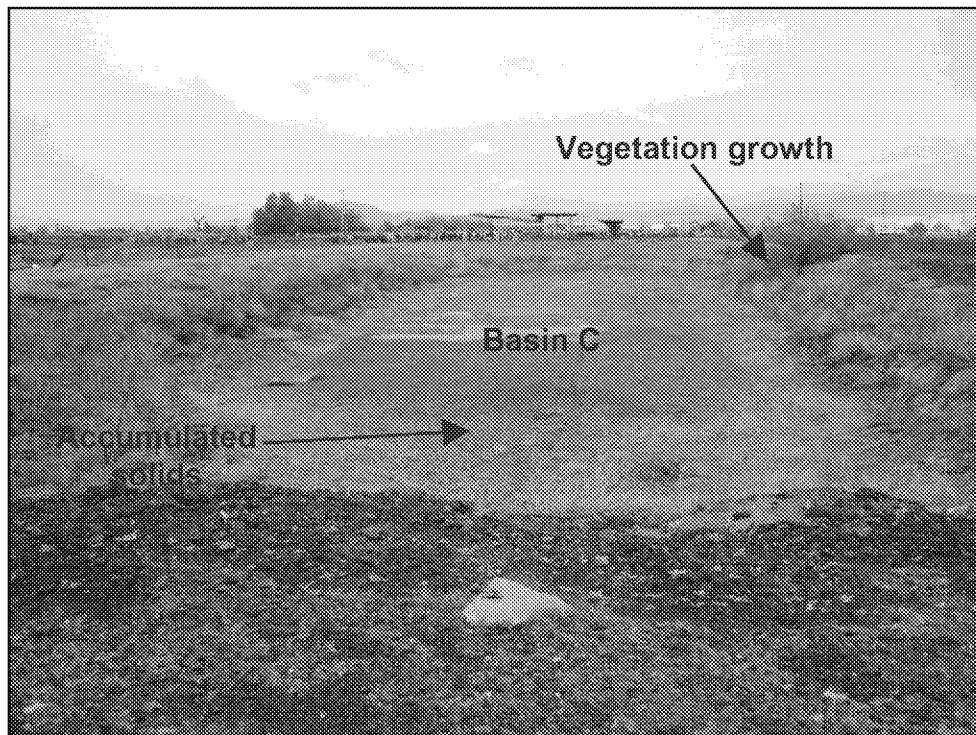
6. Accumulated manure solids and vegetation growth was observed in basins B and C in the northern portion of the Facility and in basin D in the southeastern portion of the Facility (refer to Photos 4, 7, 12, and 13). The Discharger must design and maintain all containment structures per the approved EWMP as required by Provision VII.C.3.a of the Permit.

5. The inspector observed, during the inspection, that vegetation growth potentially affecting the containment structure capacity was present in basin C located in the northern portion of the Facility (refer to Photos 12 and 13). Section 1.5.4 - 'Operation and Maintenance' of the approved EWMP states that the Discharger shall "maintain weed control at the top and inside of the pond embankments. As a result, the overall capacity of the basin at the Facility may be diminished. Provision VII.C.3.a of the Permit states that "the discharger shall design, construct, and maintain containment structures to retain all wastewater within the facility, including all process wastewater and all precipitation on, and drainage through, manured areas resulting from rainfall up to and including a 25-year, 24-hour rainfall event." The Discharger must design and maintain all containment structures per the approved EWMP as required by Provision VII.C.3.a of the Permit. This is a recurring issue identified in a previous inspection conducted on December 9, 2011.

Photograph 12. View facing south of basin C. Note the basin did not contain a depth marker. Also note accumulated solids and vegetation growth was observed in the basin.

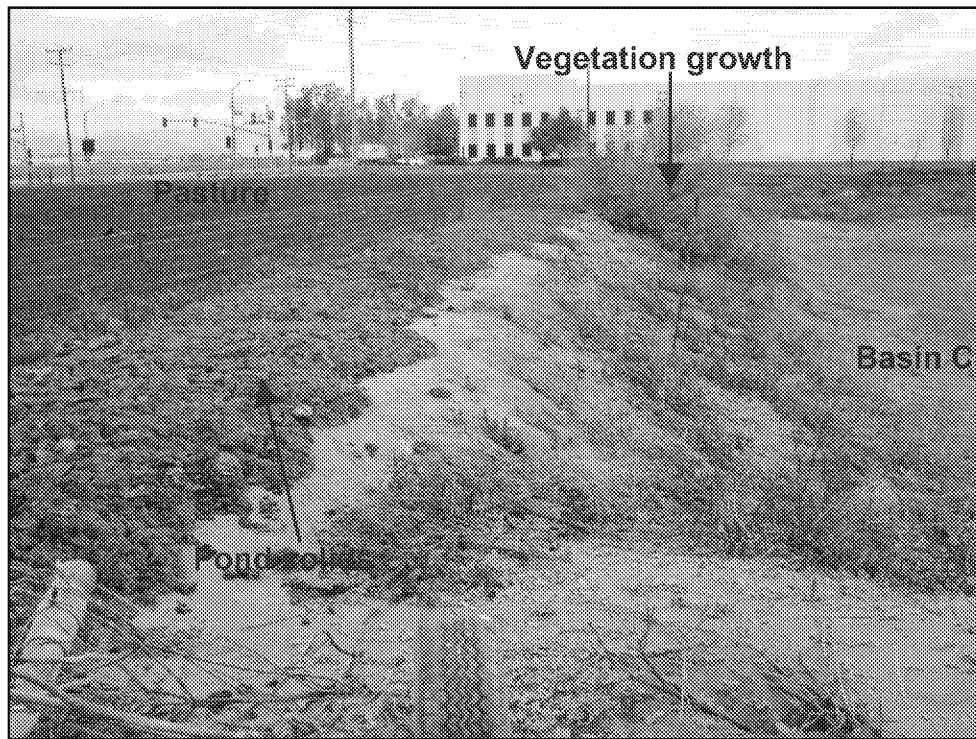
Photograph 13. View facing north of pond solids stored on the west berm of basin C. Also note the basin did not contain a depth marker, and was observed with accumulated solids and vegetation growth.

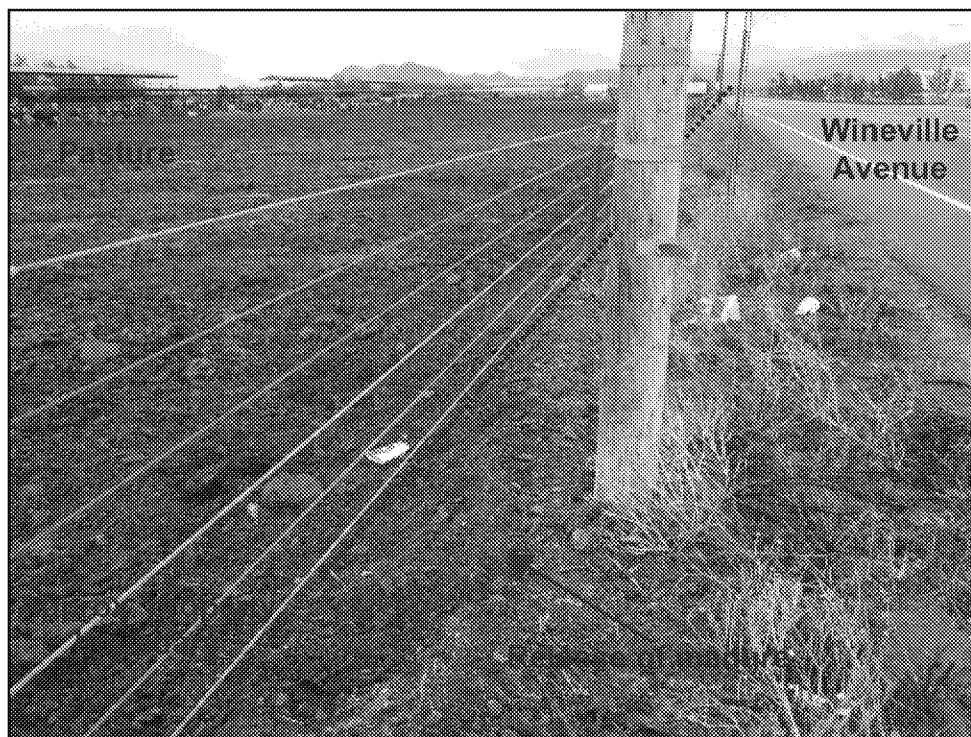
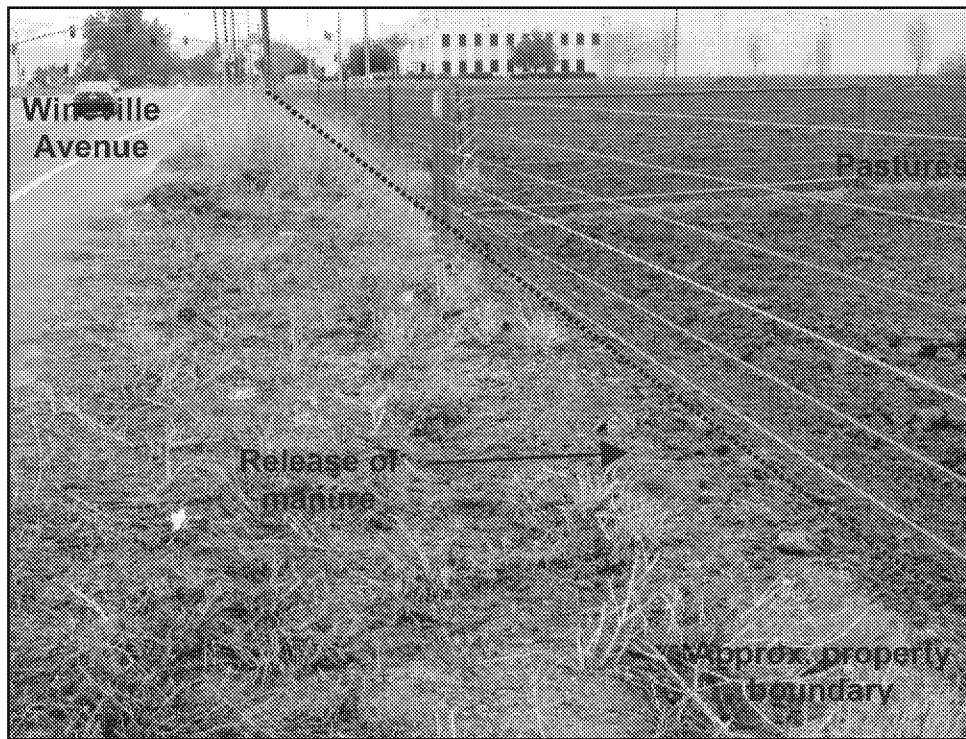
4. A release of manure offsite onto Wineville Avenue right-of-way was observed along the western Facility perimeter originating from the northwestern pastures and public manure stockpile (refer to Photos 16 through 19). A release of manure offsite to land and property not owned or controlled by the Discharger is prohibited by Discharge Prohibitions IV.A-B of the Permit.

1. The inspector observed, during the inspection, a release of manure offsite onto Wineville Avenue right-of-way along the western Facility perimeter (refer to Photos 16 through 19). Manure was released offsite from the pastures in the northwest portion of the Facility (refer to Photos 16 and 17) and from the public manure stockpile located along the central-west Facility perimeter (refer to Photos 18 and 19). The inspector did not receive any information regarding the offsite release of manure from the Facility representative. It should be noted that an adequate contiguous containment berm had not been implemented along the western Facility perimeter. Discharge Prohibition IV.B of the Permit states "disposal of manure to land is prohibited." In addition, Effluent Limitations and Discharge Specification V.1.a of the Permit specifies that pollutants may be discharged from the Facility if "the production area is designed, constructed, operated, and maintained to contain all manure, litter, and process wastewater including the runoff and the direct precipitation from a 25-year, 24-hour rainfall event." This is a recurring issue identified in a previous inspection conducted on December 9, 2011.

Photograph 16. View facing south of a previous release of manure offsite from the northwest pasture onto the Wineville Avenue right-of-way.

Photograph 17. View facing north of a previous release of manure offsite from the northwest pasture onto the Wineville Avenue right-of-way.

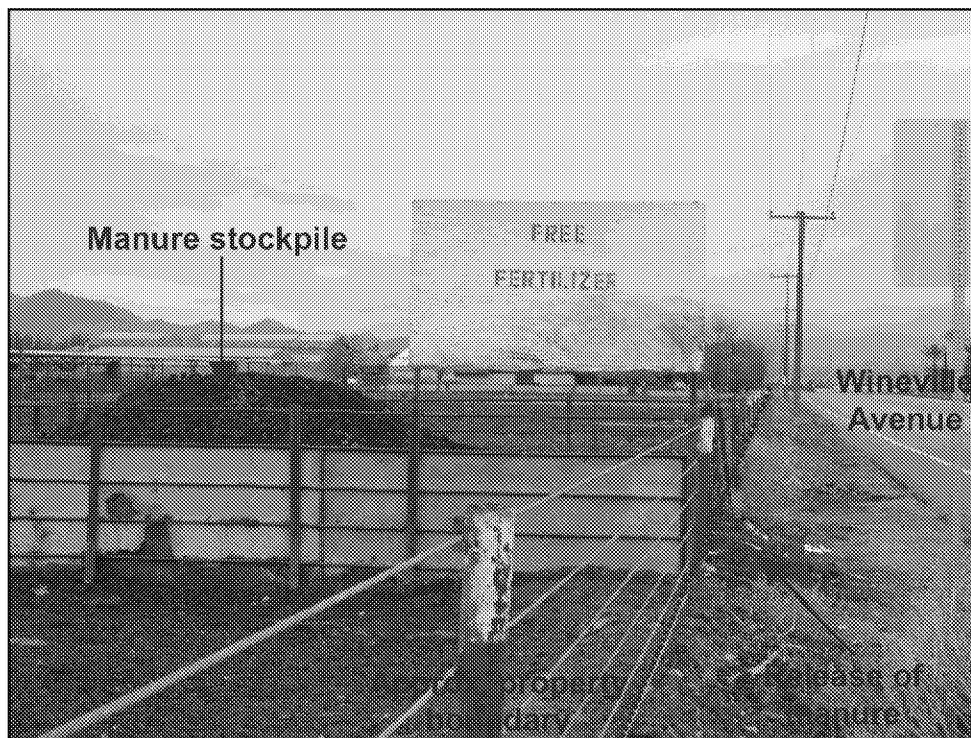
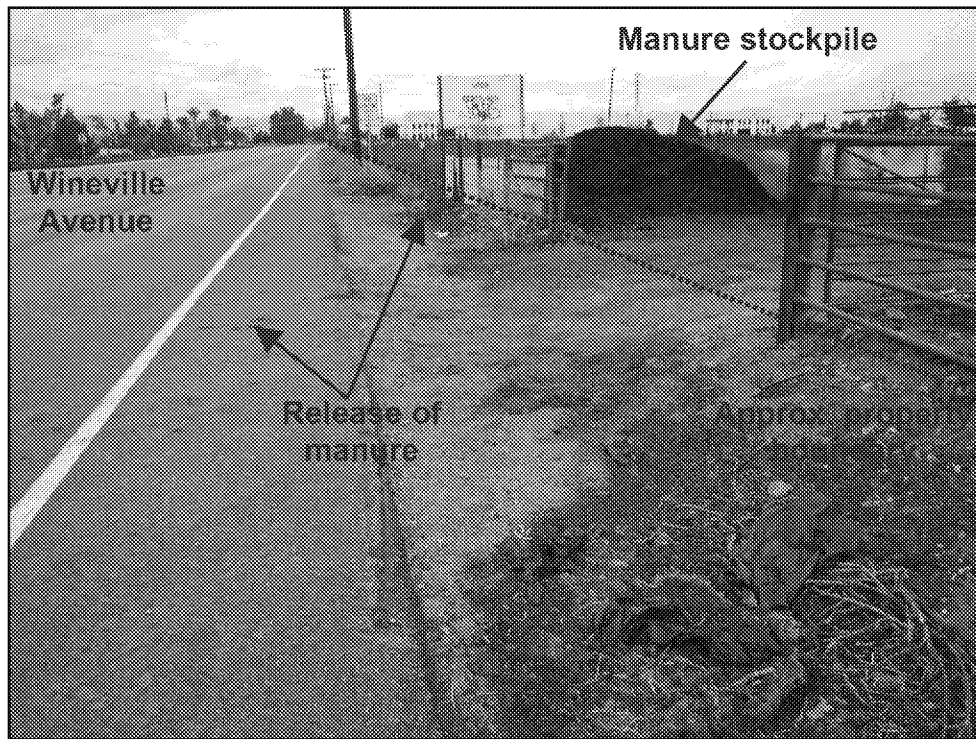
Photograph 18. View facing south of a previous release of manure offsite onto the Wineville Avenue right-of-way from the public manure stockpile located along the central-west perimeter of the Facility.

Photograph 19. View facing north of a previous release of manure offsite onto the Wineville Avenue right-of-way from the public manure stockpile located along the central-west perimeter of the Facility, shown in Photograph 18.

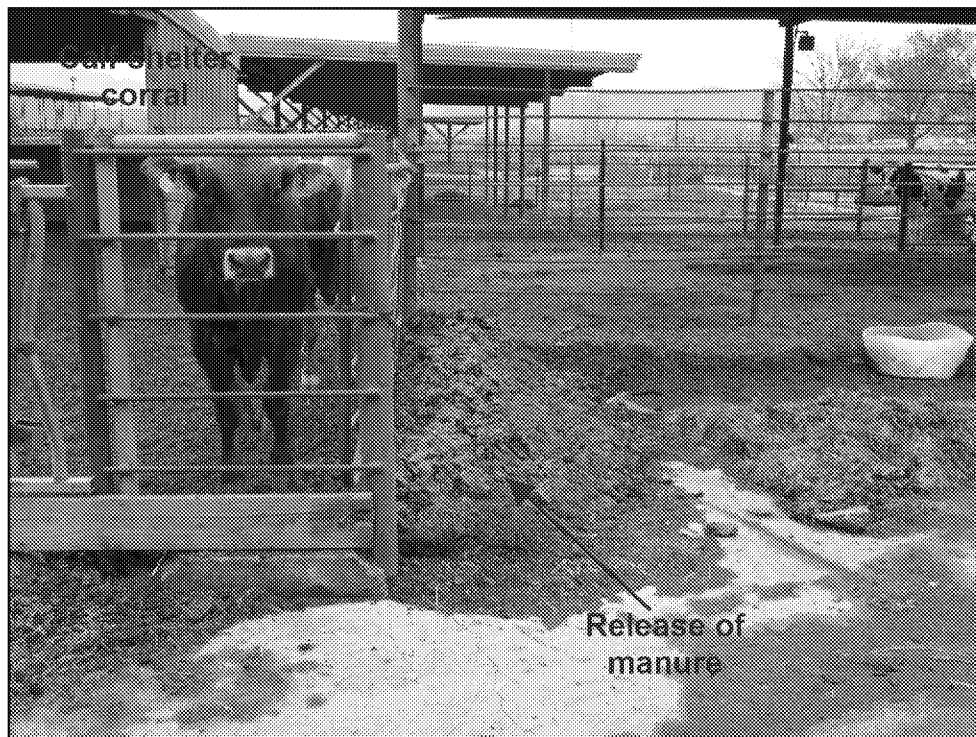
5. Manure was observed to have been previously released out of the calf shelter corral onto an onsite roadway in the southwestern portion of the Facility (refer to Photo 20). Corrals must be designed and maintained to contain all manure as required by Effluent Limitations and Discharge Specification V.A.1.a of the Permit.

2. The inspector observed, during the inspection, a release of manure out of the west side of the Calf Shelter corral onto an onsite roadway in the southwest portion of the Facility (refer to Photo 20). Corrals (i.e., animal confinement areas) must be designed and maintained to contain all manure, litter, and process wastewater as required by Effluent Limitations and Discharge Specification V.A.1.a of the Permit.

Photograph 20. View facing south of a previous release of manure out of the calf shelter corral onto an onsite Facility roadway.

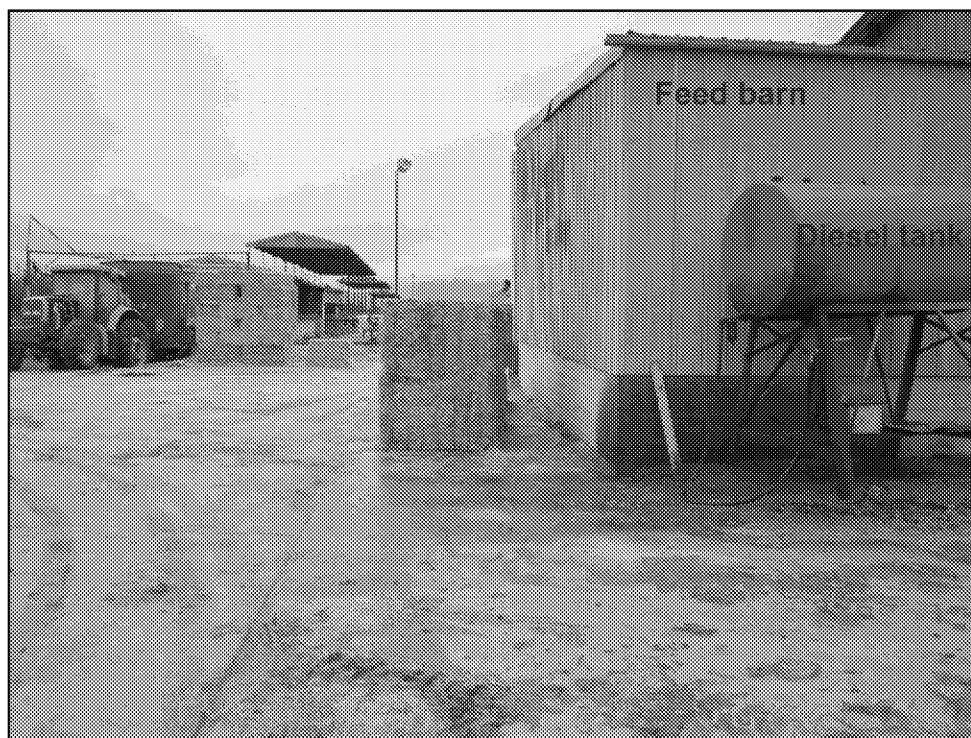
3. The inspector observed, during the inspection, that secondary containment was not provided for an elevated fuel storage tank on the northeast side of the Feed Barn (refer to Photo 21). Fuel product staining was observed on the impervious surface below (refer to Photo 22). Provision VII.C.5.h of the Permit states that "chemicals and other contaminants handled on-site shall not be disposed of in any manure, litter, process wastewater, or storm water storage or treatment systems." The inspector did not observe a disposal of chemical into any of the areas outlined above; however, the lack of secondary containment and staining creates a potential for chemicals to be spilled and/or contribute pollutants to storm water runoff on the impervious roadway.

Photograph 21. View facing south of a diesel fuel tank located on the northeast side of the feed barn. Note the tank did not contain secondary containment and diesel fuel product was observed on the impervious surface below.

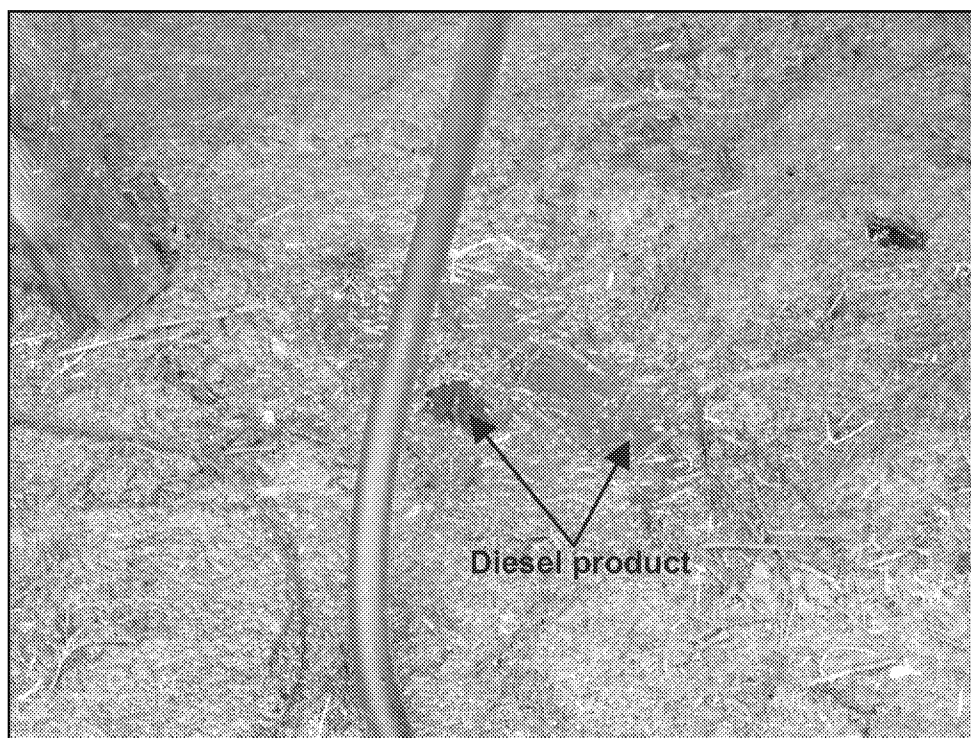
Photograph 22. Close-up view of the diesel fuel product on the impervious surface below the diesel fuel tank, shown in Photograph 21.
